## DC ground fault locating under difficult conditions An AC coupling tale...

### CASE STUDY

## DC ground fault locating in the presence of unwanted AC coupling

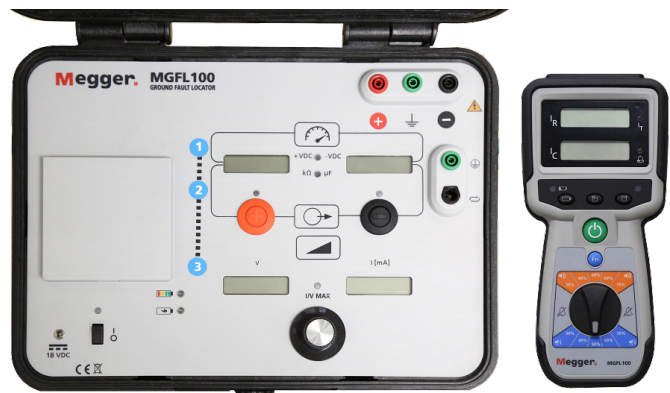
The MGFL100 is a battery ground fault locator. It can locate faults up to 400 kΩ. It can automatically identify real faults as well as leakage current. The unit will alarm when it locates the real fault.

The MGFL100 also can trace faults on IT grounded AC systems. In addition, the MGFL100 receiver can be placed in a 50/60 Hz mode to trace any AC current.
