Ground fault tracing: CT magnetization

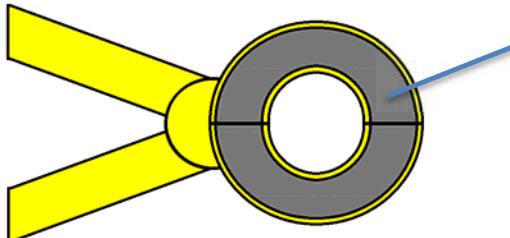
The iron core will have wire wrapped around it in order to transfer an AC signal. However, a DC signal will magnetize the iron core.

When tracing ground faults on ungrounded DC systems, one should not assume that there will be no DC current flowing through the circuit. If a current clamp (CT) is placed on a line with DC current, the DC current will cause the CT, namely its iron core, to magnetize. The higher the DC current, the stronger the magnetization will be.

This can make removing the CT quite difficult. The CT can be damaged in the process of removal. In some cases, the CT cannot be removed from the line.

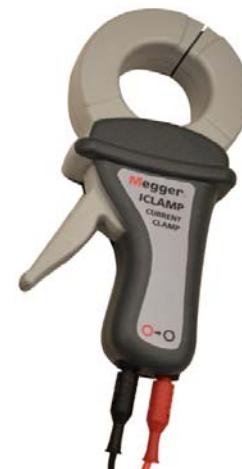
The mini active CT for the MGFL100 uses a flux gate technology, allowing a gap in the core. This also greatly reduces magnetization effects.

The MGFL100 CT is very sensitive but will not have any significant magnetization. This is because the core is made of a mu-metal compound. This core maintains high permeability but is far less prone to magnetization. If it is placed on an energised DC line, it can still easily be removed without any damage.

Using these current clamps will eliminate magnetization issues due to DC current.
