SONAVU+

THE NEXT GENERATION OF ACOUSTIC IMAGING

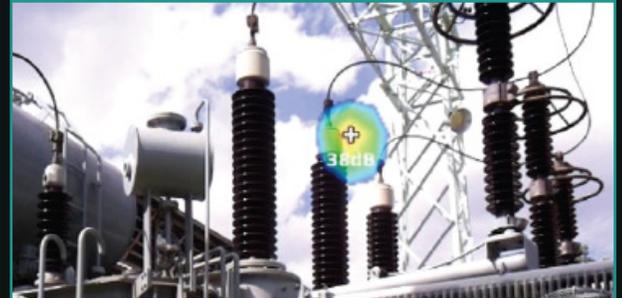
ELECTRICAL SYSTEM RELIABILITY

Issues like arcing, tracking, and corona discharge generate high-frequency sound, often undetectable by the human ear. Acoustic imaging inspection makes these faults visible, allowing maintenance teams to pinpoint and address them before they escalate.

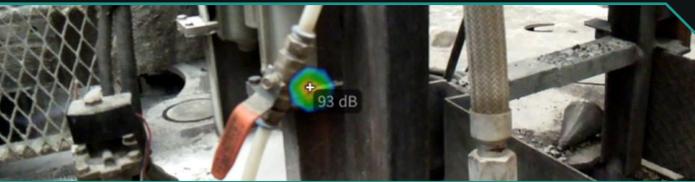
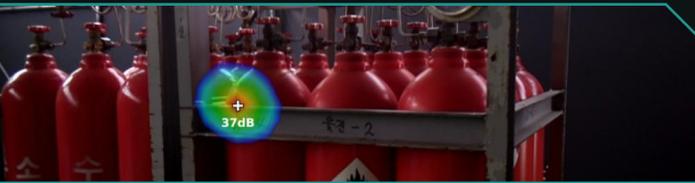
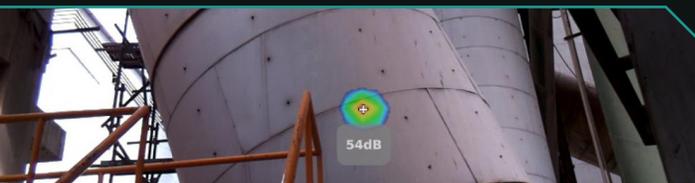
LEAK DETECTION

Acoustic imaging makes locating and visualizing leaks in real time easy... Even in noisy environments. When leaks are identified promptly, energy costs go down, system efficiency goes up, and compressed lifespan is extended.

Fugitive emissions threaten safety and compliance. But locating them is challenging due to low pressures and hazardous environments. SonaVu+ delivers sensitivity, range, and ATEX availability for safe, reliable inspections.

Vacuum leaks create system inefficiencies, energy waste, and can potentially damage products and equipment. Acoustic imaging is a fast and reliable way to locate these leaks by visualizing the high frequency sounds they produce.

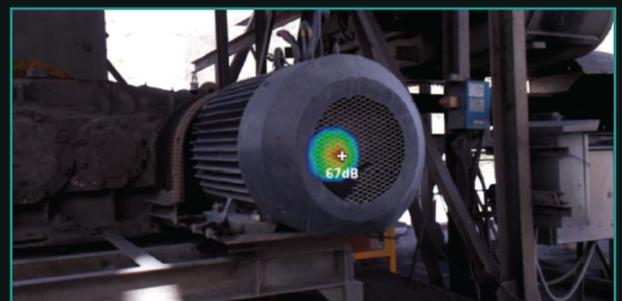
MECHANICAL

Acoustic imaging inspection is a powerful tool for monitoring critical drivetrain components such as couplings, conveyors, belts, chains, and drives. These assets often operate under heavy loads and are prone to wear, misalignment, and lubrication issues, which generate high-frequency sound as friction and impact increase.
